Investigation of October 13, 1991 Elf Exploration, Inc., Oil Spill Lease OCS-G 9637 South Timbalier Block 38

Gulf of Mexico
Off the Louisiana Coast

Steve Ledet
Paul Marsh
Burt Mullin

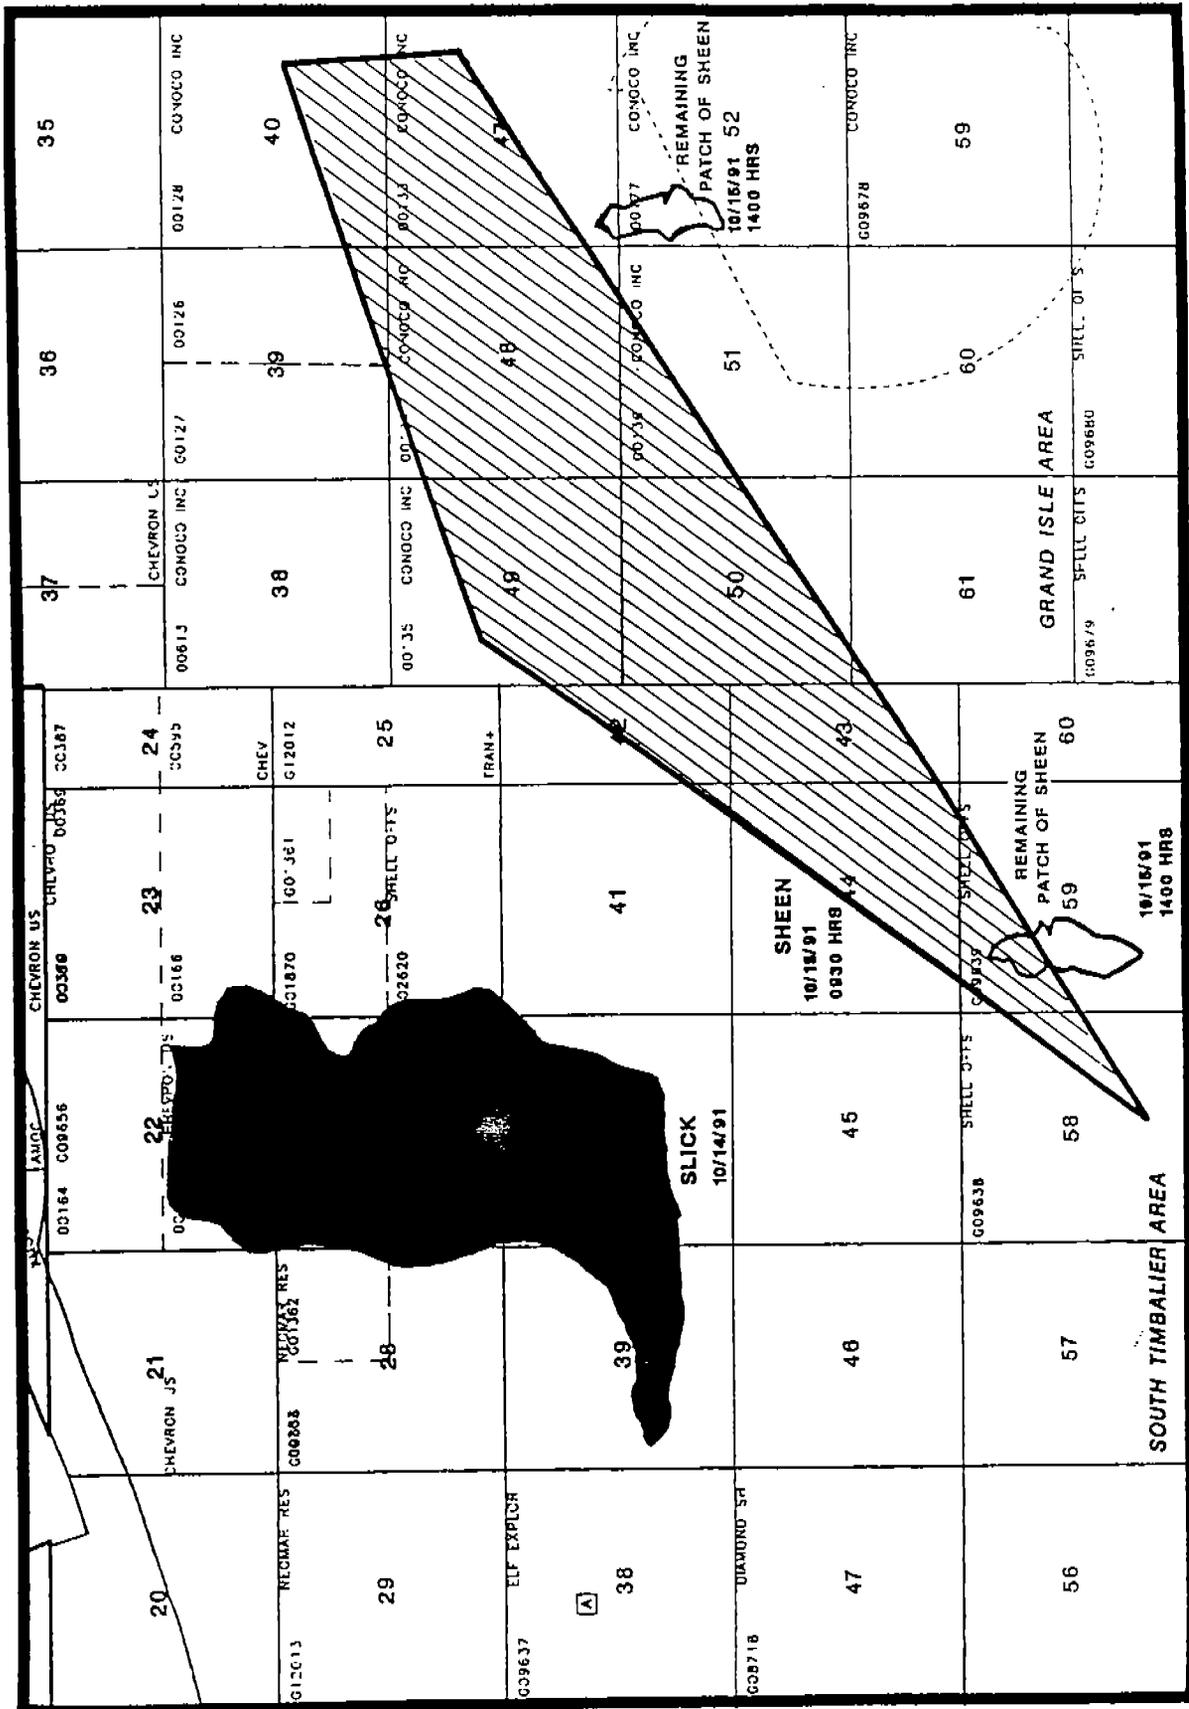
Helicopter Reported Spill Sighting

On October 14, 1991, a Petroleum Helicopters Inc. pilot passing over South Timbalier Block 38 noticed a sheen. The original slick reported by the helicopter pilot was 7 miles long by 3 miles wide, consisting of a light sheen containing numerous heavy patches. Seas were reported at 1 to 5 feet, with a northeasterly current carrying the slick. The original sighting was approximately 7 to 8 miles from shore.

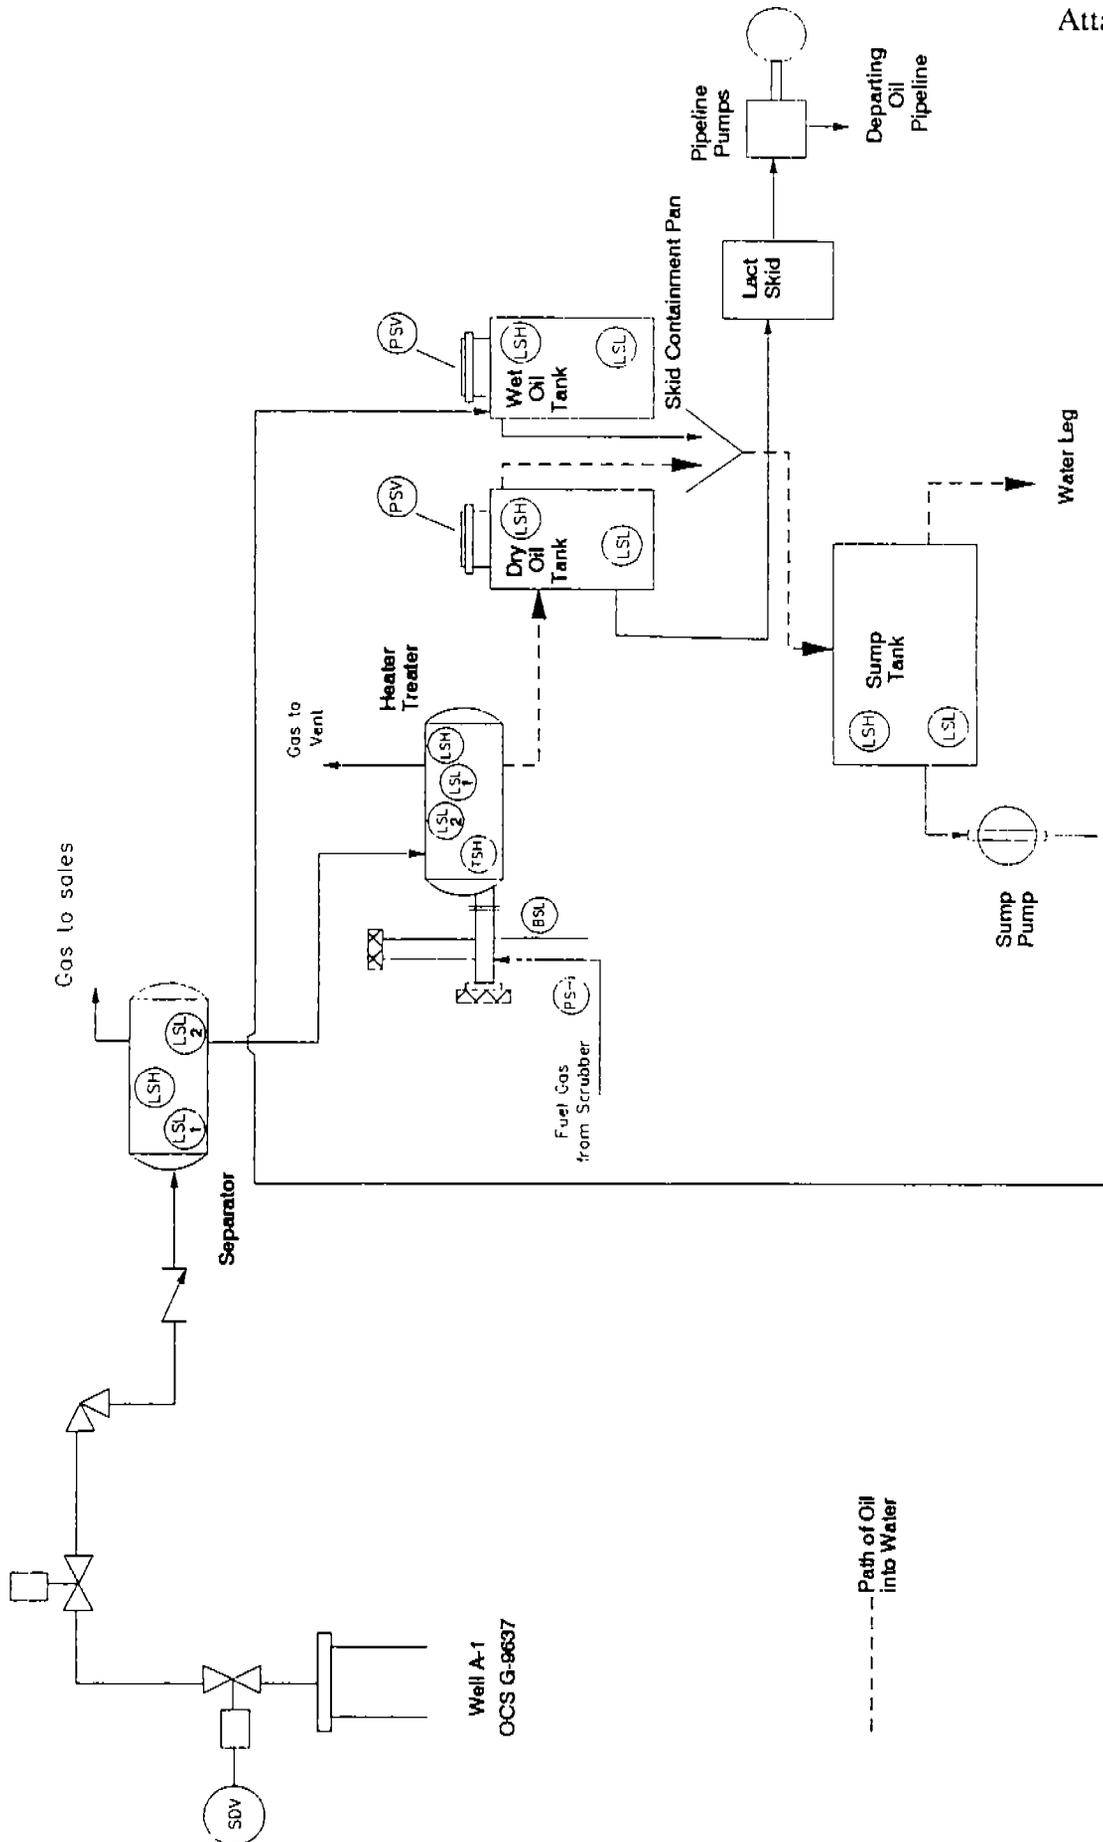
Flow Diagram

With the pipeline pumps not functioning and the well still flowing, oil production continued to fill the dry oil tank (see flow diagram, attachment 3). The dry oil tank filled until the level safety high sensor was activated, as indicated on the master panel. Although the safety system was designed to shut-in production in the event of a level safety high sensor signal in the dry oil tank, the device tripped at the pneumatic panel, but the panel failed to shut-in production.

The dry oil tank level safety high was the primary safety device to detect such an upset and shut-in the platform. The shut-in circuit, which receives the level safety high signal, had been successfully tested on several occasions before and after the oil spill. However, after continued testing of the circuit following the spill, the circuit's reset pilot (spool valve) failed in the partially cleared position and did not initiate platform shut-in. The spool valve has a pin used to hold the spool valve in the "cleared" position during start-up and pressurization of the panel. The pin is designed to release the spool valve automatically when the panel is pressurized and the circuit clears. If the pin fails to release the spool valve, the circuit fails in a partially cleared mode and does not shut-in the platform. This is commonly referred to as "cross-spooling." The spool valve was removed and disassembled, at which time small amounts of debris (sand, rust, etc.) were found within the spool valve. Apparently on the day of the incident, the level safety high was activated and a signal was received by the panel, but either low operating pressure on the panel and/or debris in the spool valve allowed the valve to cross-spool, which did not result in shut-in of the well. Therefore, the dry oil tank continued to fill and eventually oil entered the overflow line and spilled into the skid containment pans (drip pans), through the skid drain system and subsequently into the sump tank.

Oil continued to fill the sump tank, displacing water out of the tank. The level control signaled the sump pump to start and pump the sump tank oil bucket to the wet oil tank. The sump pump, a double-acting diaphragm pump, appeared to be air-locked and did not function. A properly working sump

pump could have prevented or lessened the severity of the spill by pumping the oil into the wet oil tank. The wet oil tank level safety high should then trip and shut-in the platform. Nonetheless, oil continued to fill the sump. As the oil rose in the sump tank, the level safety high sensor was not activated, as the upper level safety high sensor isolation valve was closed. The isolation valve is used to bypass the vessel during testing. This valve probably had mistakenly been left closed. This human error eliminated the secondary protection against such an upset. The oil completely displaced the water in the sump and forced the water out of the water-leg and the spilled oil into the Gulf.

If the overflow line from the dry oil tank had been piped to the wet oil tank, this incident may have been avoided.
